COMMON DEFECTS IN SOLAR PHOTO VOLTAIC MODULES

FIDATO CONSULTANTS PRIVATE LIMITED

Defects in Solar PV Modules

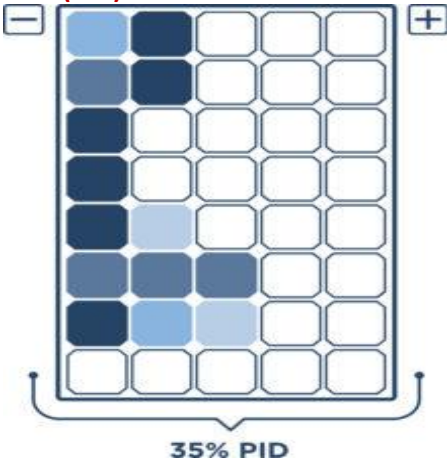
Defect Type & Image	Description	Analysis / Test/Certification
<p>1. Potential Induced Degradation (PID)</p>

<p style="text-align: center;">35% PID</p>	<p>PID affect occurs most commonly in the PV module that is closest to the negative pole, during operation, the cell's voltage is negative pole voltage. In contrast, the frame of the PV module has 0 V, because it is grounded for safety reasons. This electrical voltage between the cells and the frame can cause the electrons to come loose from the materials used in the PV module, migrate into the electrical field, and then discharge through the grounded frame, this phenomenon is termed as potential induced degradation (PID).</p>	<p>It is strongly recommended to ensure the test certificate under IEC 62804 along with IEC 61215 and IEC 61853 and other Anti PID / PID free measures.</p>
<p>2. Hot Spot</p>

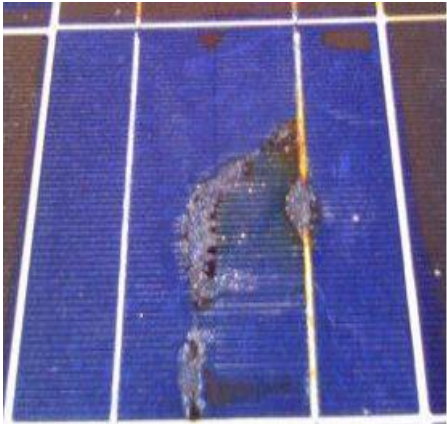
<p>Hot-spot heating occurs in a module when its operating current exceeds the reduced short-circuit current of a shadowed cell or group of cells within it. The probable causes of hotspot formation are non-uniform illumination of the module (local shadowing), individual cell degradation due to cracking or loss of a portion of a series-parallel circuit due to individual interconnect open circuits.</p>	<ul style="list-style-type: none"> • Hot spot endurance test under clause 10.9 of IEC 61215 • Mechanical load/cycling test under clause 10.16 of IEC 61215

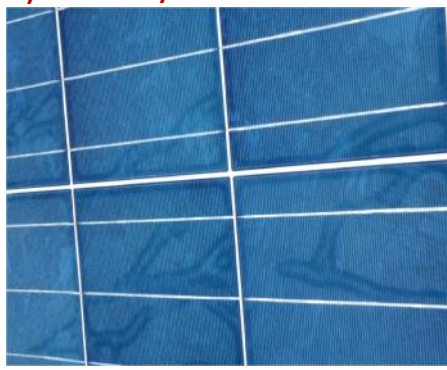
<p>3.) Snail Trail/ Snail marks</p>

<p>It is a new phenomenon in crystalline PV Modules referred as one of the most common defect. It is nothing but the formation of Nano particles of silver carbonate on fingers of cells, thus de coloring the affected part and is shown as snail trail marks. The carbonate part is extracted from the already existing pores in the wafers as it has been found that these pores do possess CO₂ and O₂ elements within</p>	<p>To analyse the micro cracks we have to go for EL tests, snail trails can be visually seen in the affected modules.</p>

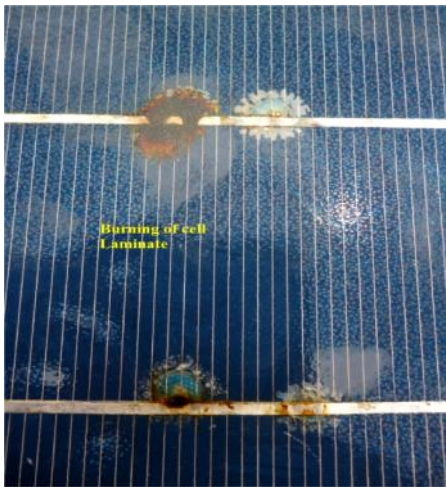
4. De-lamination

This phenomenon can be referred as removal of EVA from cell, it is resultant of worst quality of material used in manufacturing. Thus results in delaminating of the affected part. Wrong process parameters or cheap material can result in a de-lamination of the EVA later in lifetime. The layers of EVA dissolved and get a whitish color or color fading. Due to the de-lamination, moisture can get to the cell which leads to cell corrosion and an ongoing performance loss. Further, the light transmission is reduced.

Whitening /color fading as de-lamination in PV modules, Cells burnt after de-lamination

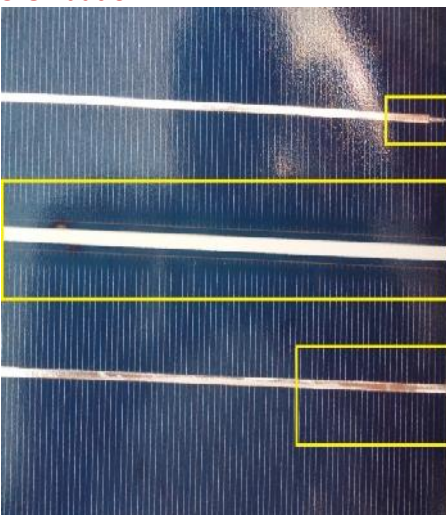
5.Oxidation

Oxidation is a very common phenomenon, nothing but the corrosion of different parts of the PV modules viz. Fingers or Bus bars etc. De-coloring /Bronze coloring of Fingers are termed as oxidation; the factor involved due to which the oxidation phenomenon happens is moisture penetration within the modules. This moisture can enter through tedlar/back sheet, through glass or through any other open part of module.

Patch formation and browning of fingers as affected area of oxidation

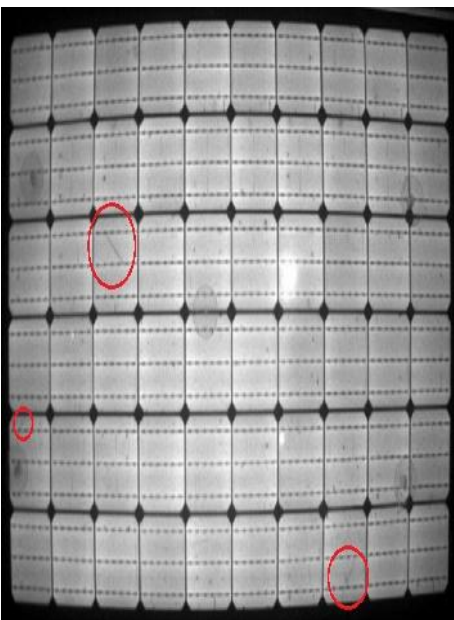
6. Micro Cracks

Micro cracks are one of the major and most adversely affecting defects in PV Solar industry. These are hairline and even narrow cracks formed in solar cells. These cracks are mainly formed during the encapsulation process/manufacturing process, yet there are least chances that such cracks may develop during conveying/transportation or during operations. Due to cracks the junctions within the cell acts as open circuit in affected area, thus reduces the efficiency drastically. Further these micro cracks also results in snail trail in some cases due to reaction with moisture.

To analyze micro cracks in Modules , Tests like Flash Test/ EL tests , Mechanical load test 5400 Pa , 200 humidity freeze cycle Under IEC 61215.

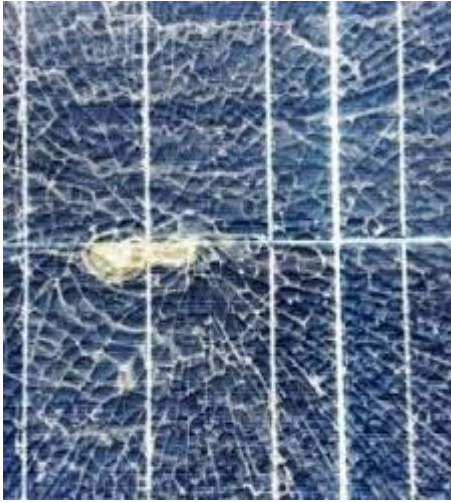
7. Glass Breakages

Generally the glass used in crystalline Modules is Tempered glass, it is not that easy to break these glasses, yet in some situation due to external pressure these glasses can get broken. If the quality of glasses are not up to the mark, they may shatter due to thermal shocks too.

Easily observed by the user.

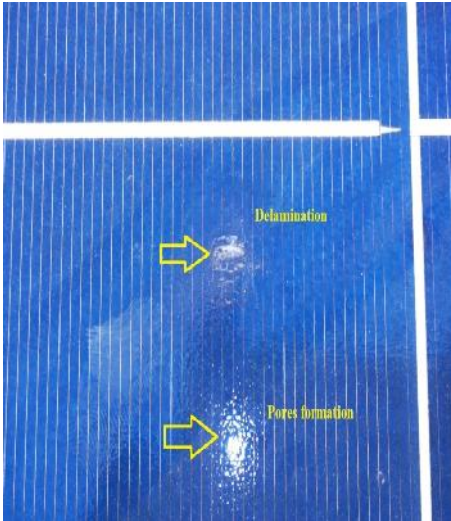
8. Bubbles / Pores formation

This defect is also a result of bad quality of Manufacturing material used, Due to worst quality of Tedlar /back sheet, moisture penetrates within the cell and EVA and thus forms bubbles and pores after evaporation. Cells may burn at the affected area during course of time by this defect.

Sometimes during wafer manufacturing itself, pores reside within the cell. Visual inspection shall be done.

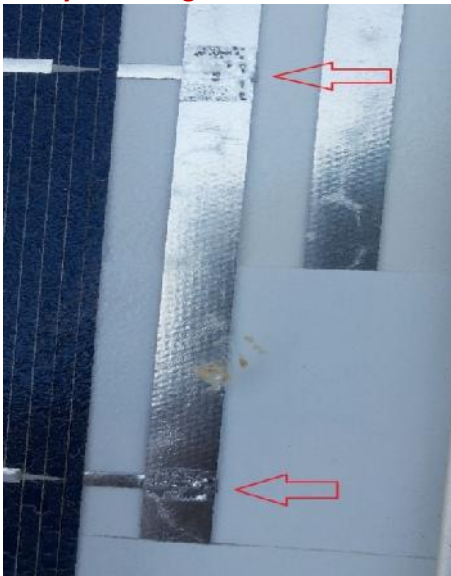
9. Dry Soldering

This defect occurs due to improper soldering of Bus Bar and fingers on cell by unskilled resources or in absence of proper automation. This defect results in formation of hotspot, part area may induce high resistance thus burns the cell, EVA and tedlar/Back sheet.

- Some of the module manufacturing vendors do not impose required quantity of Silver paste to reduce costs, thus gives defects while manufacturing.
- Due to dry soldering Bumps/ De lamination can also be seen in some cases.

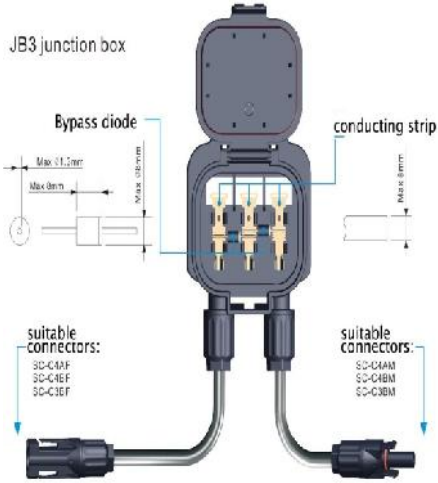
10. Burning of diodes /displacing of junction boxes

Since diodes (Bypass/ blocking) are one of the most important elements of crystalline PV modules. Due to material quality defect or improper capacity sizing or loose connection they get burnt, thus degrading the module efficiency . We must always prefer automated unit for module manufacturing.

- Due to unskilled resources or bad quality of adhesive the junction boxes gets displaced.
- The diodes shall strictly follow specific codes viz IEC 62548.

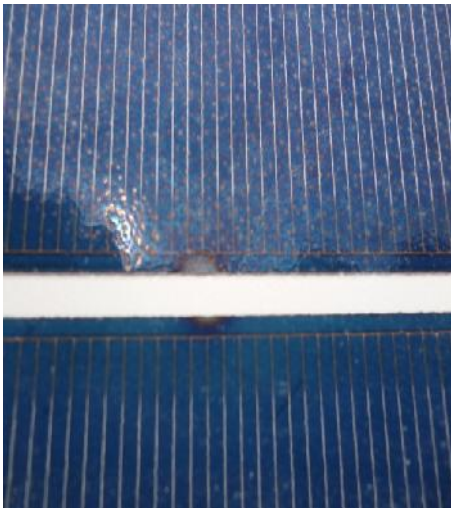
11. Visual defects

These defects do not impose any efficiency/generation degradation in the modules. Cells from some manufactures show dark markings on the edge of the cell. These spots are due to the specific production process and not have any negative influence to the performance or life time of the cell , provided they are not covering the conversion area of panel and not blocking the solar radiation.

These defects are included under clause 10.1 in IEC 61215

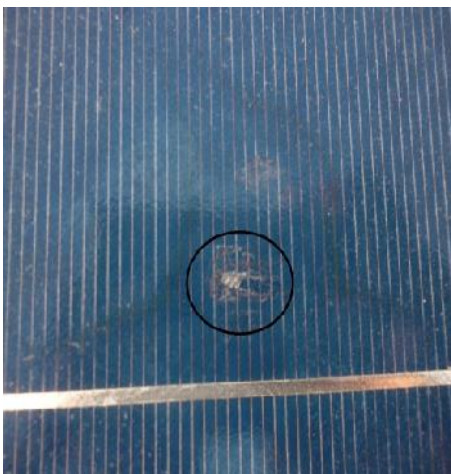
12. Defects Due to Mis handling at site

These are most common defects that can be easily avoided provided care must be taken during PV module installation. Glass Breakages is the most common of all defects under this category & should be taken care to avoid formation of micro cracks within. Avoid pasting of stickers on cell area, and paint/cement/concrete residuals should be properly washed out so that no formation of hot spots take place there.

Modules must be properly placed/mobilized/installed.
